Contract No. CON00008697
Study No 10001550
Final Report

Corrosion in Systems Storing and Dispensing Ultra Low Sulfur Diesel (ULSD), Hypotheses Investigation

Battelle Memorial Institute
505 King Avenue
Columbus, OH 43201

Final Report

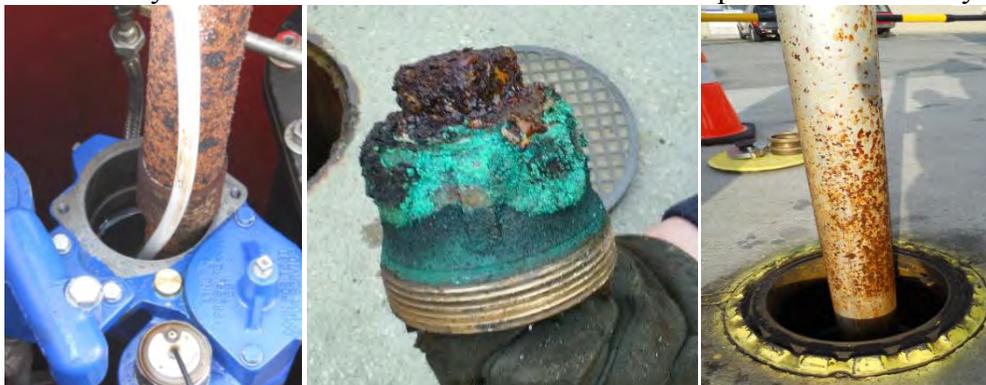
Figure 1. Corroded ULSD equipment: Corroded carbon steel submersible turbine pump (STP) shaft removed from pump housing, CA-1 (left), brass ball float extractor cage plug, NY-2 (middle), aluminum drop tube, NC-1 (right).

The sites inspected were chosen because of the corrosion observed by the owners/operators of the sites. The corrosion is severe and according to the owners happened over a relatively short period of time. During the inspections in this project, severe corrosion was observed on a large number of components *within* the USTs and specifically *not* on the outside of the components in the sump pits and the dispensing systems. The corrosion scrape samples taken from the internal components were coated with corrosion. *The scrape sample results support the conclusion that the internal components made up of all different metals are deteriorating in ULSD USTs.*

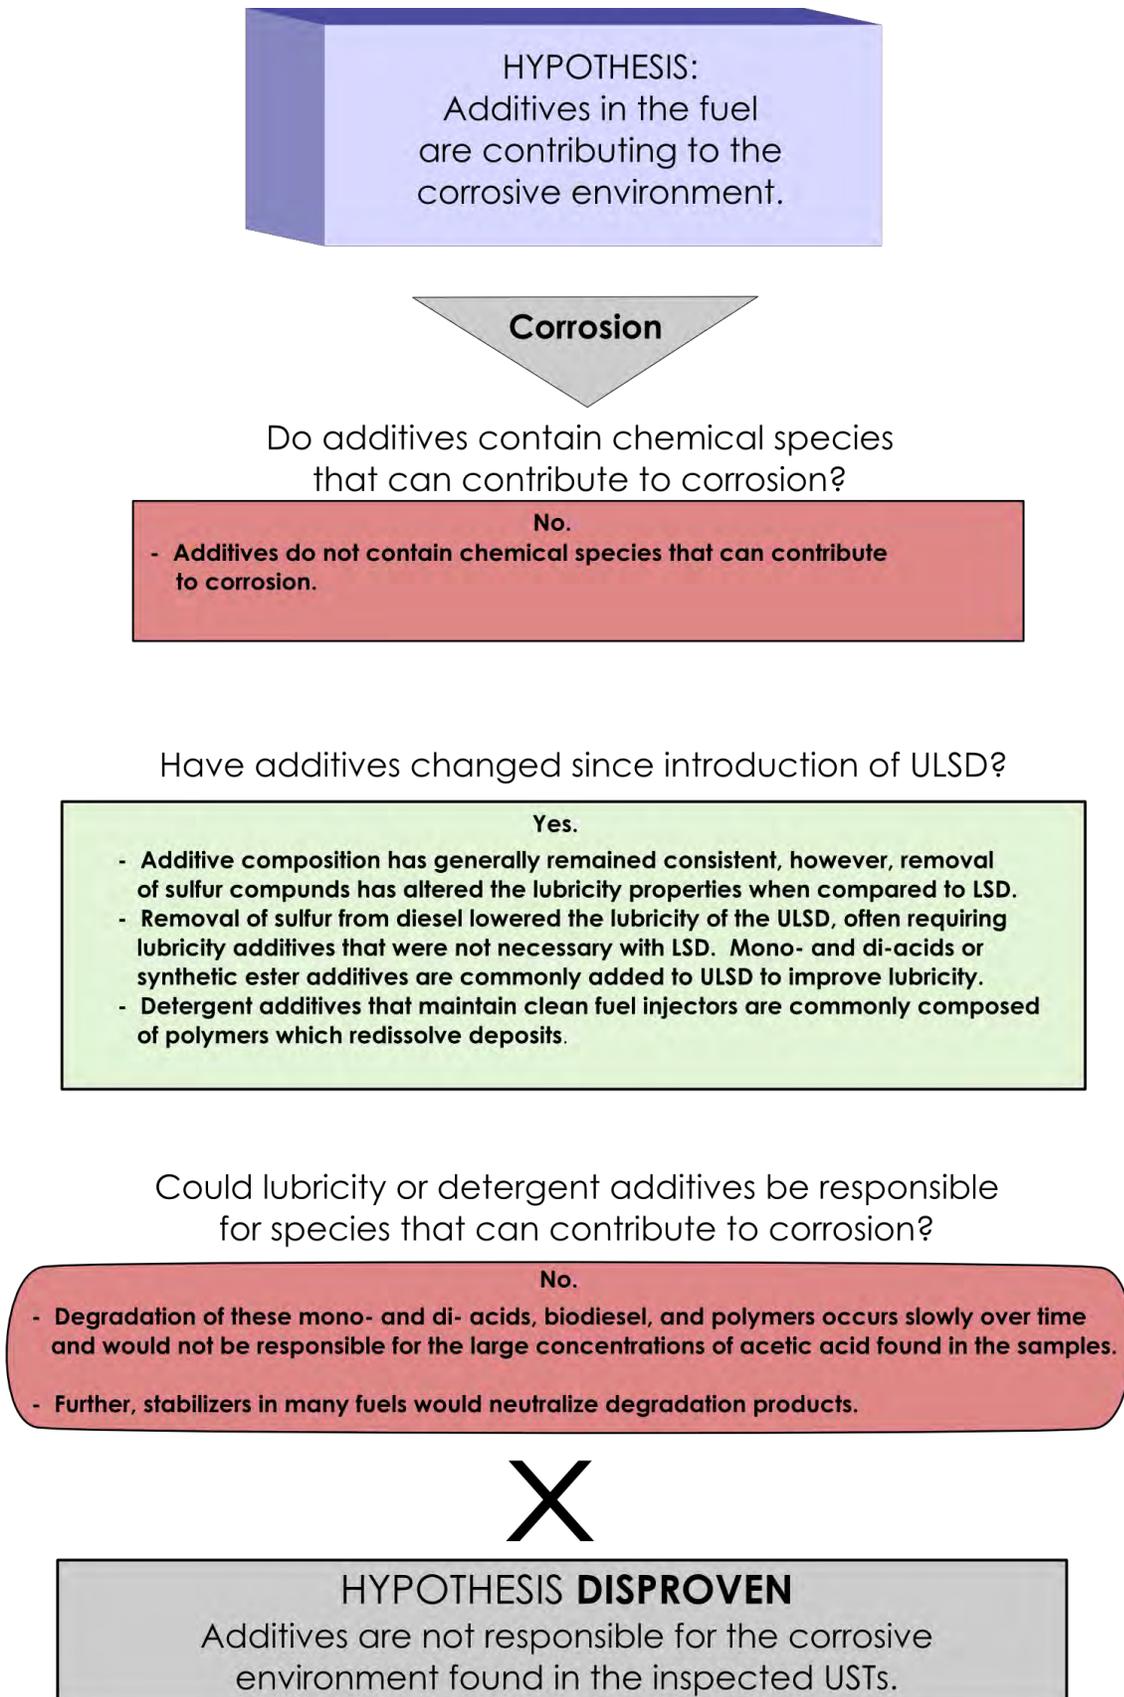
Figure 2. Additives Hypothesis Evaluation

The analysis of the fuel, water bottoms, and vapor phase also showed the presence of acetic acid in large quantities. From the literature search and discussions with additive manufacturers, there is no reason for acetic acid to purposely be added to diesel fuel. To be present in the tank at the concentrations measured, the acetic acid would have to be a significant component (or reaction product) of the fuel additive. There is minimal use of ethanol in additives and they are not widely or consistently used. For these reasons, the additives hypothesis is not believed to cause the severe and rapid corrosion occurring in UST systems storing and dispensing ULSD (Figure 2).

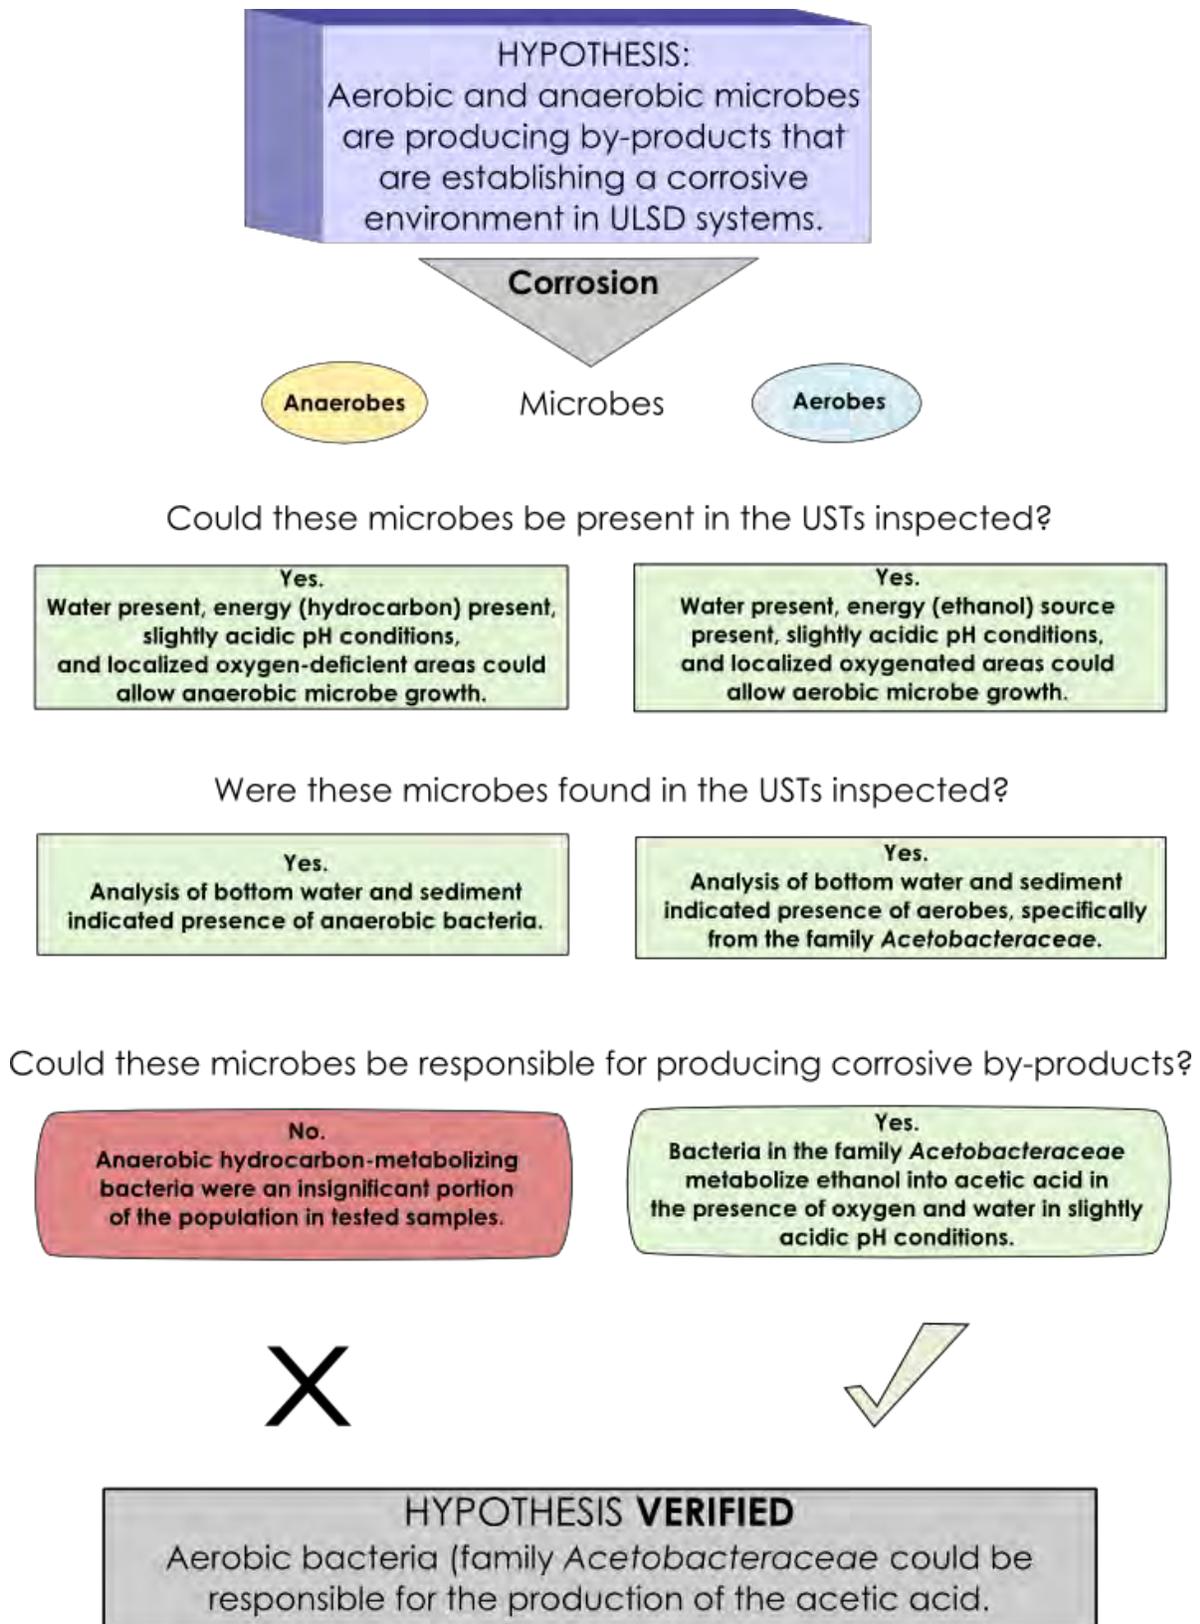
Figure 4. MIC Hypothesis Evaluation

All of the sites inspected in this research project contained microbes, although at different abundances. The dominant organisms identified from three of the sites have characteristics pertinent to the corrosion observed in all of the sites, such as acetic acid production, ethanol utilization, low pH requirements, environmental presence, and oxygen. Although geographically on opposite sides of the country, with different fuel supplies and from relatively new construction materials, the presence of the organisms was relatively uniform. The traditionally expected organisms were found in insignificant abundances. Anaerobic organisms ranged from 0% to 6% and hydrocarbon degrading organisms from the *Gammaproteobacteria* class ranged from 0.3% to 5% in the samples analyzed. This indicates that ULSD USTs are selective environments for these specialized, acetic acid producing organisms. Therefore, as shown in Figure 4, the microbial hypothesis is accepted with respect to aerobic microbes but rejected with respect to anaerobic microbes.

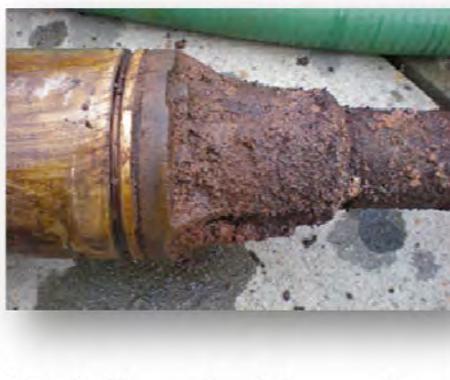
Figure 2. Example of observed corrosion.

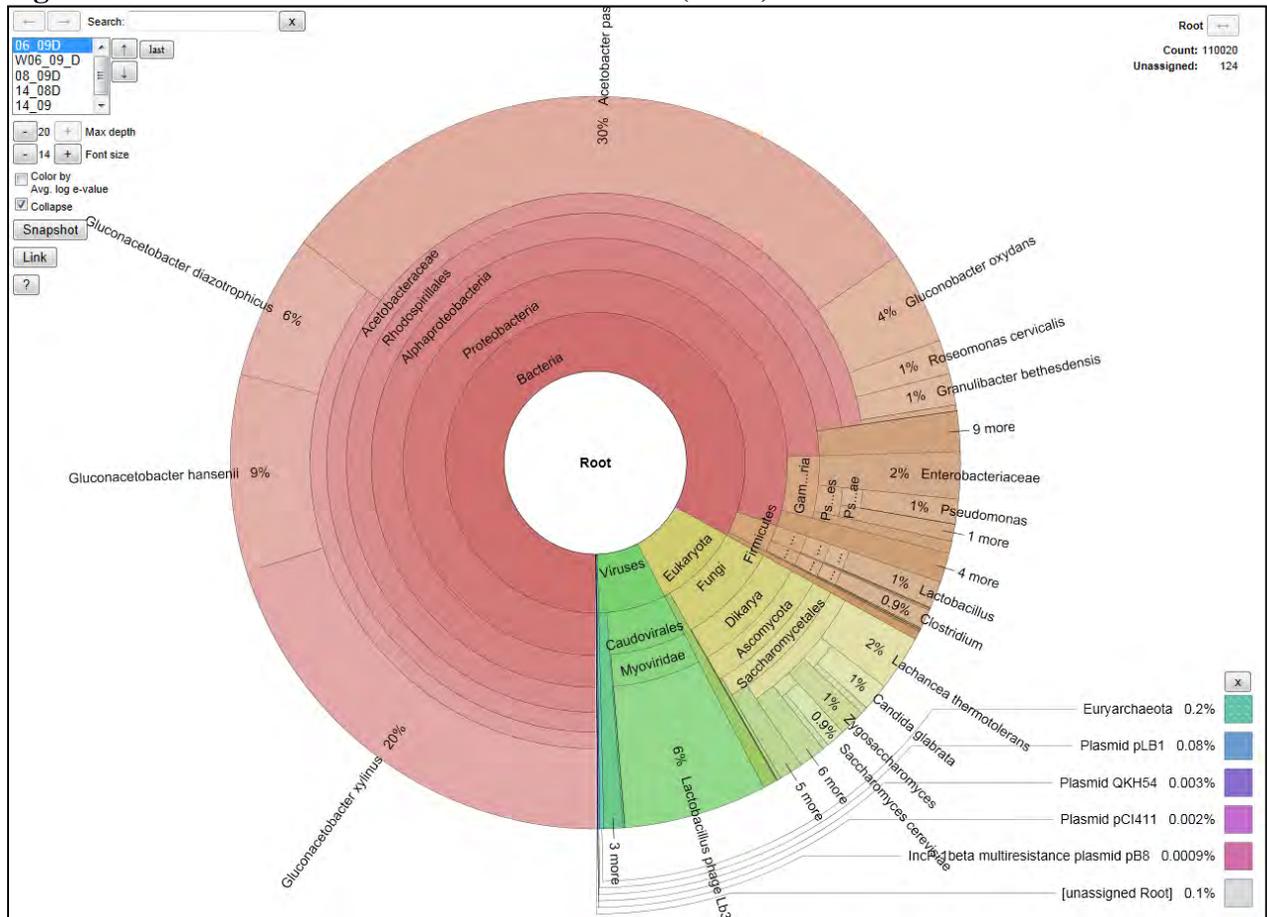
Figure D2 - 53609-08-09d Filtered Water Bottom (NY-2) Microbial Profile

Some differences were observed between sites. For example, CA-2 had predominantly *Gluconacetobacter sp.* Over 50% of the DNA identified belonged to this genus. NY-2 had higher levels of *Lactobacillus sp.* compared to NY-1 and CA-2. NY-1 showed higher levels of a fungus, *Zygosaccharomyces*, and bacteriophage (viruses that infect bacteria) compared to the other samples. Very little difference was observed between the filter water and sediment samples in CA-2, suggesting that the same organisms reside in these two sample types within this system. It is interesting to note that although the three geographically separate sites had some observable differences in abundance of select organisms, Table 5 indicates the presence of organisms was relatively uniform. This suggests that the ULSD system is very selective for specialized organisms capable of thriving in these environments, rather than a site specific or environmental effect driving the composition of microbial population.

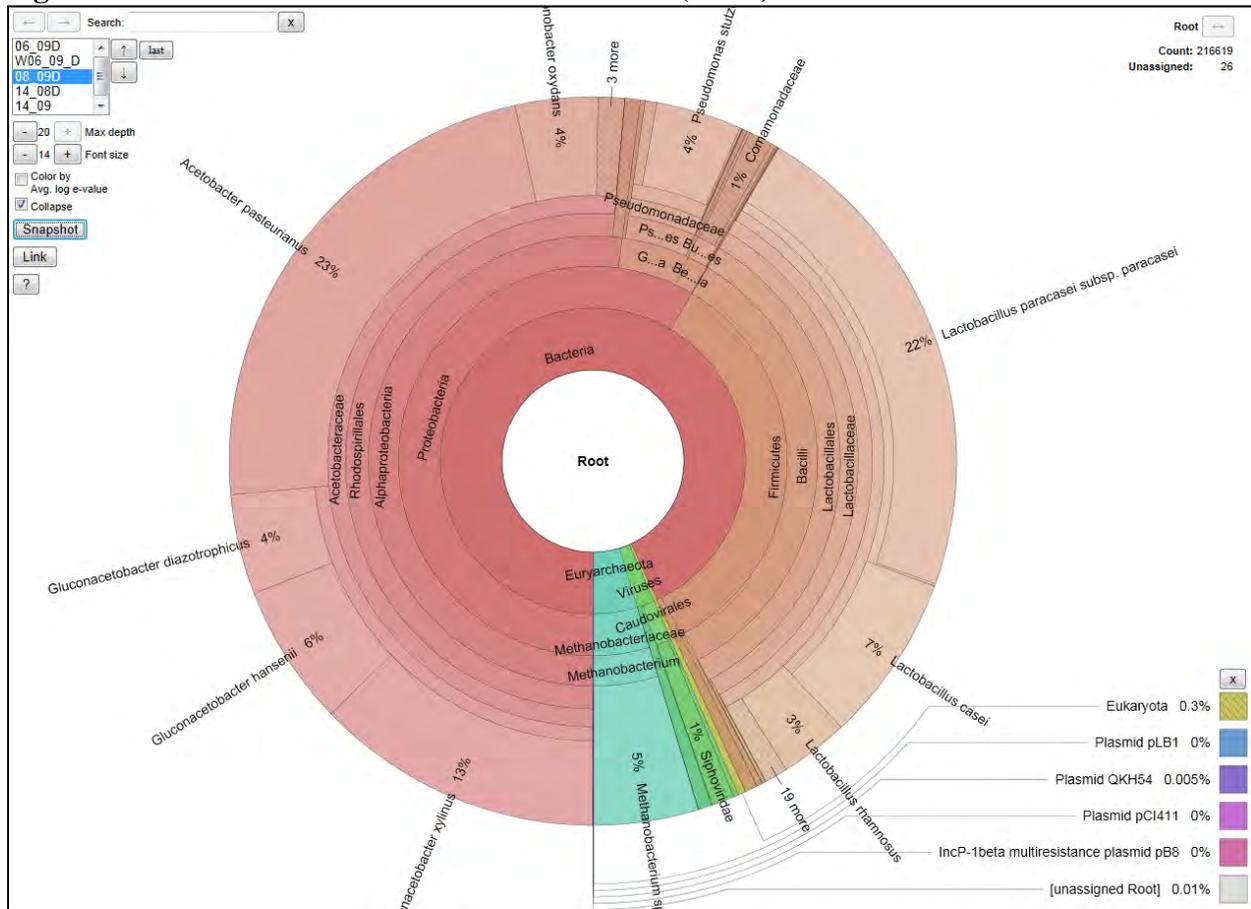
Figure D3 - 53609-14-08d Filtered Water bottom (CA-2) Microbial Profile

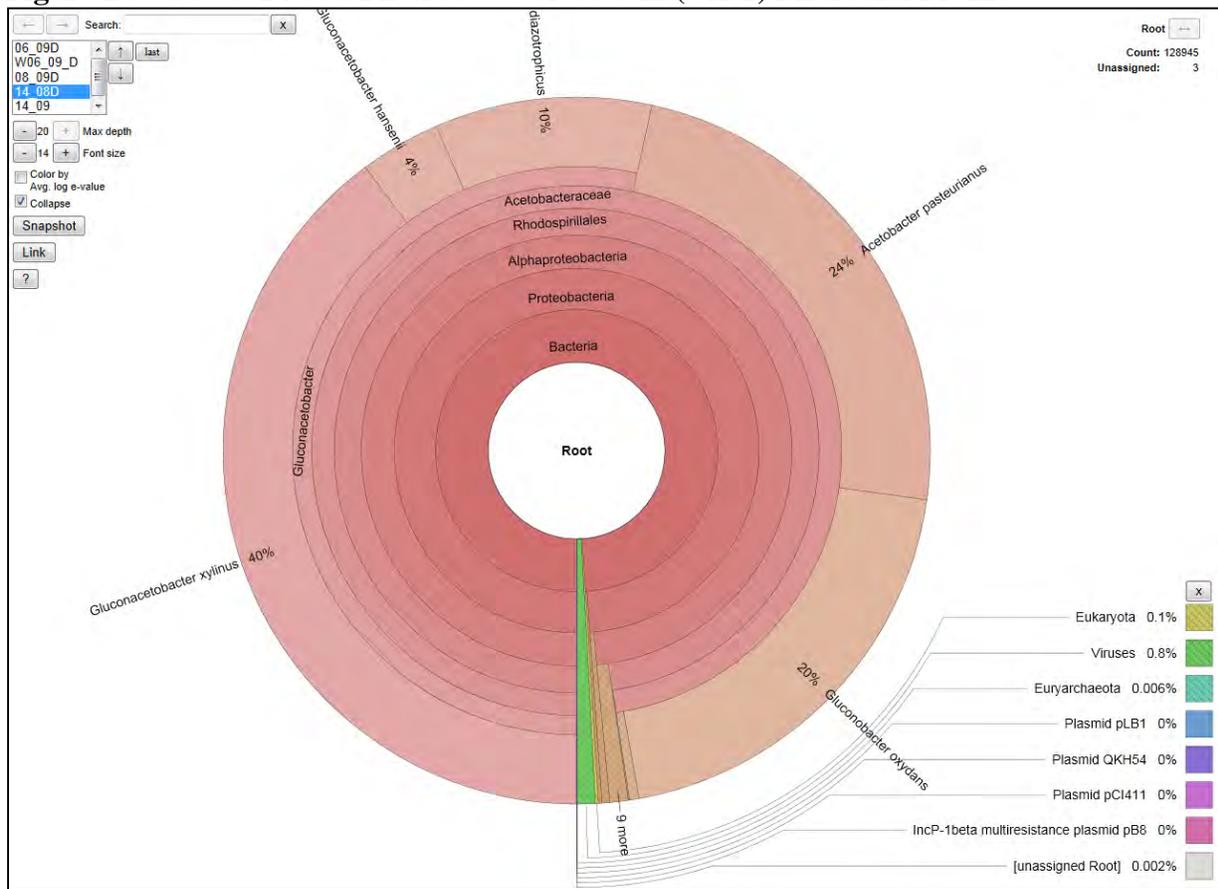
Figure D4 - 53609-14-09 Sediment bacon-bomb (CA-2) Microbial Profile
