## **Preliminary Investigation Summary of Deterioration of Fuel and Fuel Systems Storing and Dispensing ULSD Fuel at DFW Airport**

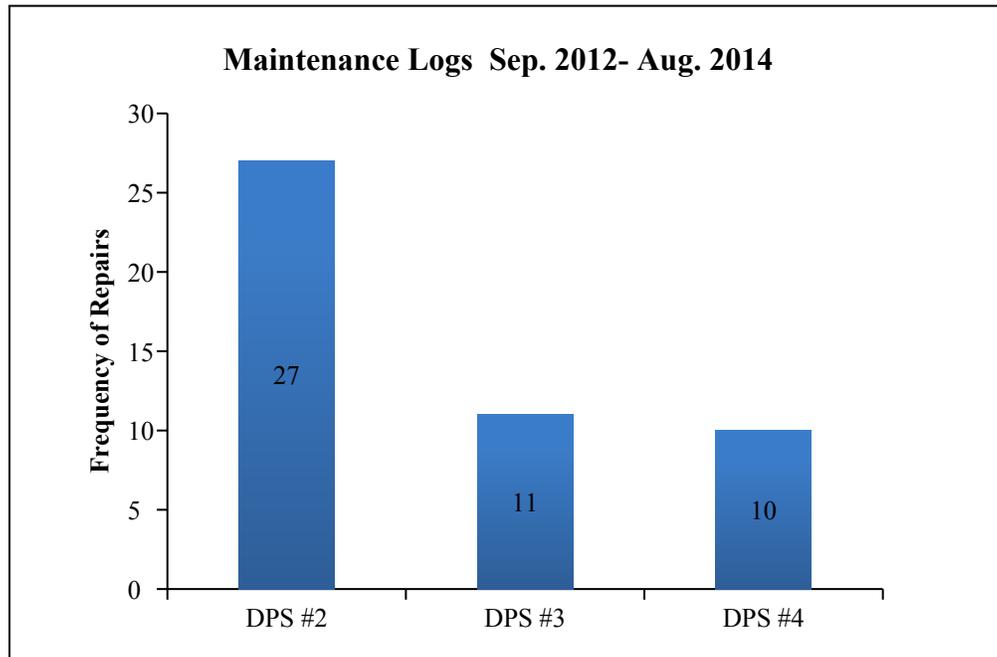
Figure 1: Frequency of repairs by station. Sept. 2012- Aug. 2014.

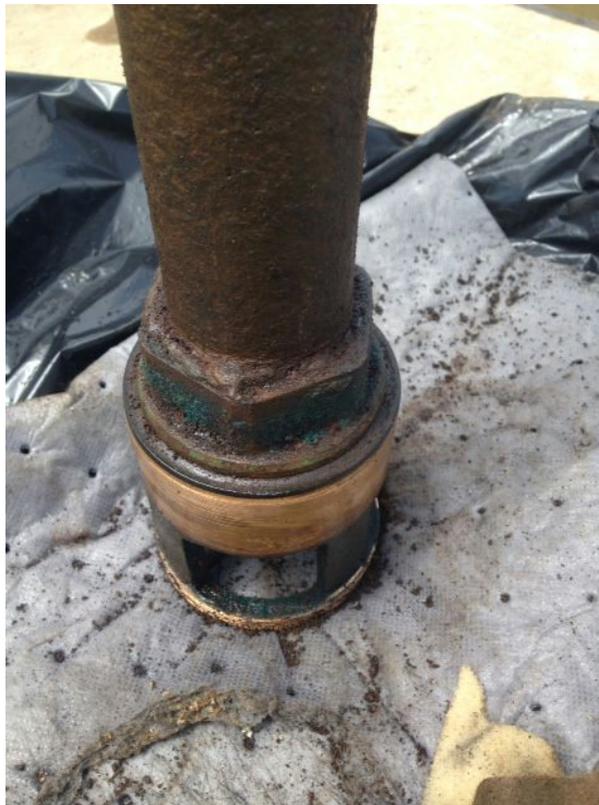
Field inspections of accessible equipment including the fill port and suction tube display conditions consistent with excessive corrosive conditions. When the suction tube was removed the corroded coating was estimated to be 1/8" to 1/4" thick (Figure 2). The filter screen at the bottom of the suction tube could not be easily removed because screws connecting the screen to the pipe were so heavily corroded. Screens and filters are especially prone to contamination as they provide a collection area with the capacity to collect both water and matter. The presence of significant amounts of precipitated materials suggests the presence of microbes. The red- brown precipitates reflect the presence of iron or iron hydroxides, or both.<sup>7</sup>

*Figure 2: The suction tube column. This is the upper length of the pipe. Note the blue discoloration of brass (indicative of exposure to acid). This photograph was taken after removal of 1/8" to 1/4" thick precipitated material.*

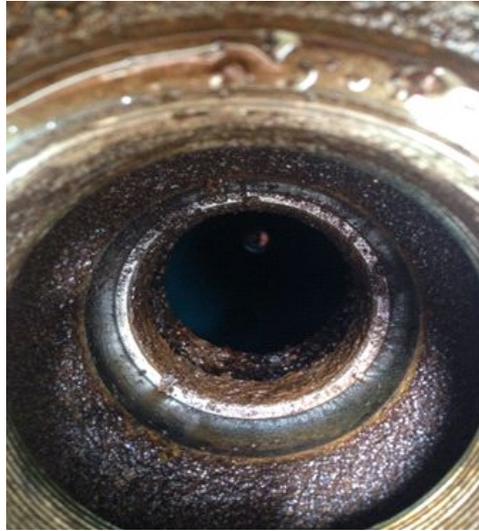
Examination of the top of the suction tube where it attaches to the sump at the surface revealed copious amounts of red-brown solids (Figure 3). This is the highest point in the vapor space and has relatively little or no contact with fuel. The significance of this finding suggests the vapor space of the tank is acidic. The pH of tank water sample was  $<4$ , an ideal pH for proliferation of acid resistant species. These findings are consistent with studies, including the Battelle Institute and API, which conclude acidic vapor space is a metabolic byproduct of microorganisms present in ULSD fuel storage systems<sup>8</sup>. Fill port photographs illustrate oxidation of brass components of the fill port (Figure 4). The blue-green discoloration indicates an acid reacting with zinc and copper. Copper and zinc are primary components of brass.

*Figure 3: The suction tube attachment to the sump. This is the highest point in the system with relatively little or no contact with fuel. This piece has no exposure to outside environment.*

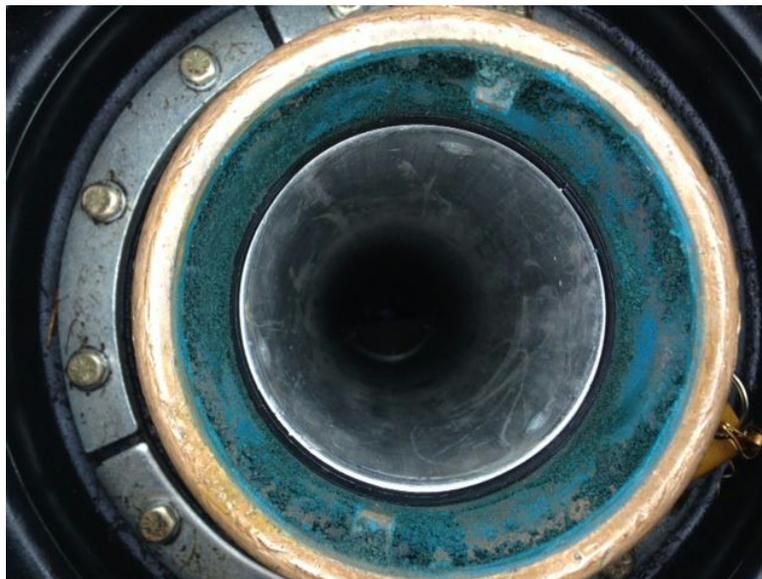
*Figure 4 : Brass fill port at DPS #2. The blue-green precipitate is the result of an oxidation-reduction reaction in the system*
